REFERENCE:
BULLETIN 25-268

DC-9

SERVICE BULLETIN SUMMARY

SUBJECT: EQUIPMENT/FURNISHINGS -
Lavatories - Modify
Forward and Aft Lavatory
Waste Container Assemblies.

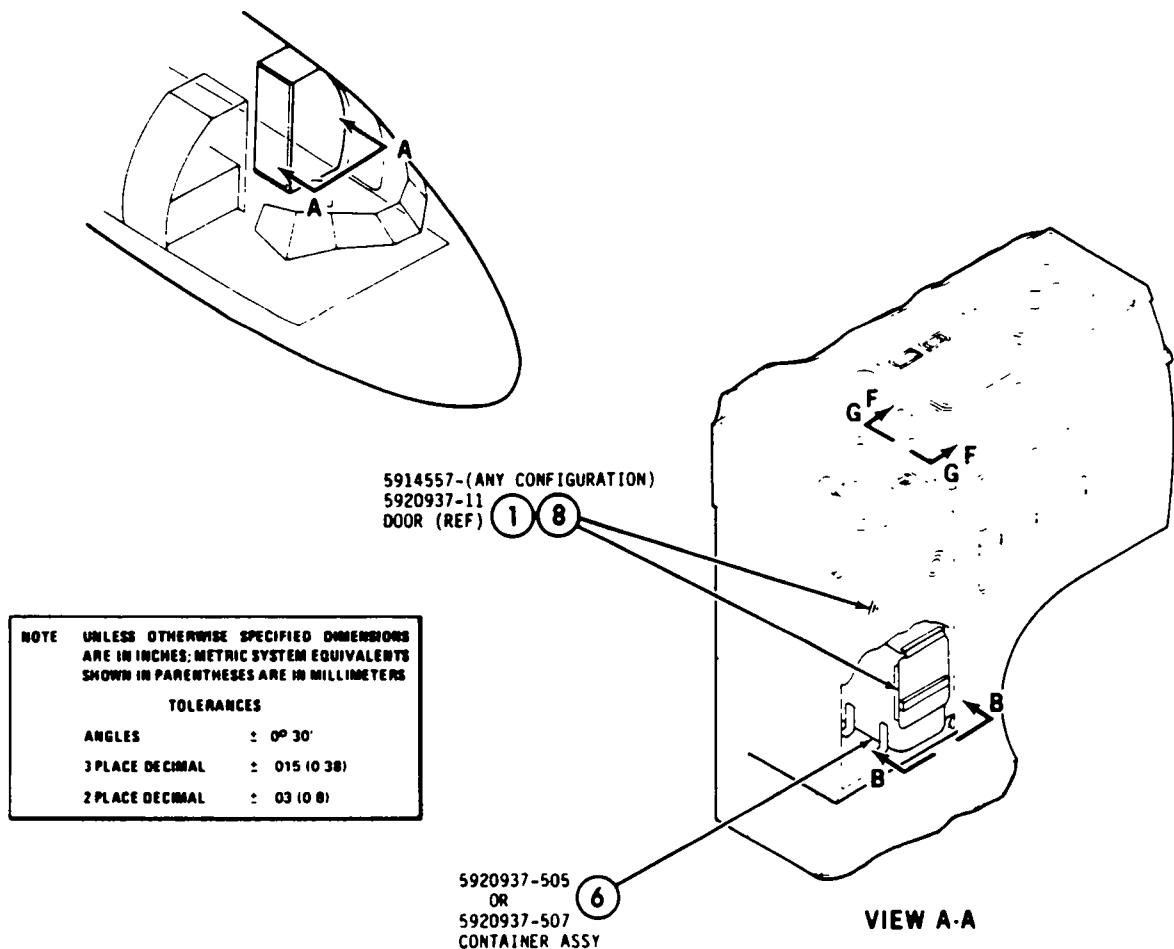
FIGURE 1 (SHEET 1 OF 6)

Five operators reported 12 instances of return spring failures on door hinge of lavatory towel waste chute. In addition, it was reported that a 1/4 inch gap existed between bottom of waste container and cleanout door. These conditions can affect fire containment capability of lavatory towel waste container. This modification closes gap and reinforces lower door area; replaces upper door and hinge assembly with a new door and improved hinge assembly on lavatory towel waste container. Accomplishment of this modification will improve service life of lavatory towel waste container and provide improved container sealing capability to enhance fire containment.

- ① OPEN AND SECURE 5914557-(ANY CONFIGURATION) AND 5920937-11 DOORS FOR ACCESS TO REPAIR AREA OF CONTAINER ASSEMBLY.
- ② CLEAN INSIDE OF CONTAINER ASSEMBLY BELOW DOOR OPENING PER CHAPTER 51-70-1 PARAGRAPH ENTITLED "REPAIR AREA PREPARATION AND CLEANING."
- ③ POSITION SR09250003-3 PLATE AND SECURE USING SR09250003-5 TAPE.
- ④ CUT THREE PIECES OF SR09250003-7 CLOTH 2 X 7 INCHES AND LAYUP PER CHAPTER 51-70-3, PARAGRAPH ENTITLED "GLASS FIBER LAYUP TO METAL REPAIRS."

- ⑤ (NOT SHOWN) ALLOW RESIN TO CURE AT ROOM TEMPERATURE; EIGHT HOURS FOR HALF STRENGTH AND 16 HOURS FOR FULL STRENGTH.

- ⑦ REFORM DOOR AS REQUIRED TO MAINTAIN .030 (.76) INCH MAXIMUM CLEARANCE BETWEEN DOOR AND CONTAINER.
- ⑧ CLOSE CONTAINER AND CABINET DOOR.
- ⑨ REMOVE 4914565-1 OR -501 DOOR ASSEMBLY AS FOLLOWS:
 - a. 4914565-1 - SEPARATE 4914565-3 DOOR FROM 4914565-5 HINGE HALF USING A SHARP EDGED CHISEL.
 - b. 4914565-501 - REMOVE TWO MS51957-44 SCREWS.
- ⑩ REMOVE 4914565-7 HINGE FROM CABINET AS FOLLOWS:
 - a. SAND FIBERGLASS FROM SURFACE OF HINGE.
 - b. USING A SHARP EDGE CHISEL, PRY HINGE FROM CABINET.
 - c. REMOVE S224504259-320 PIN AND S133509-12 SPRING.
 - d. REMOVE RESIN AND GLASS CLOTH TO SMOOTH CABINET SURFACE.
